Home Inspection Report

123 Sample St, Fairhope, AL 36532

Friday, January 4, 2019

1234

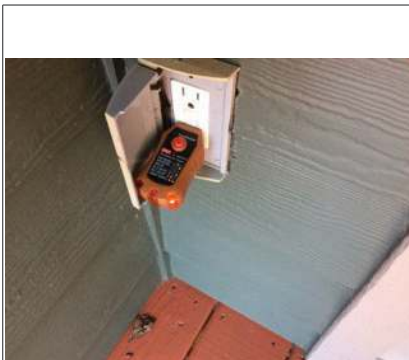
Exterior receptacle at back door is open neutral. Recommend consulting electrician for repair.

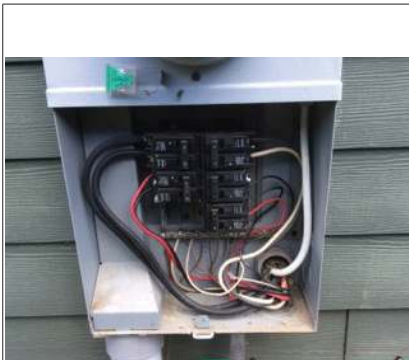
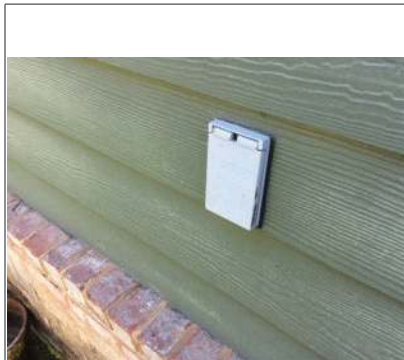
Comments GFCI on exterior receptacle on east side of home will not trip. Recommend consulting electrician for repair.

GFCI on exterior receptacle on east side of home will not trip. Recommend consulting electrician for repair.

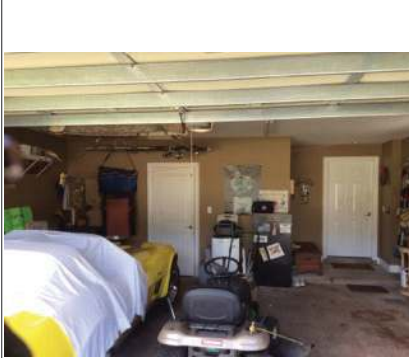
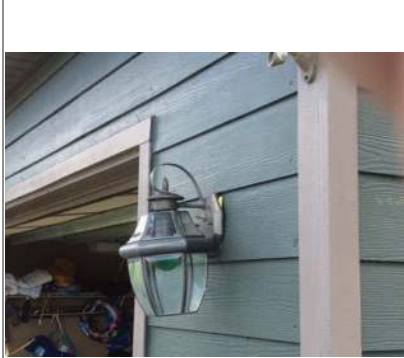
None
 Attached Detached 1-Car 2-Car 3-Car 4-Car Carport
Type
Comments Light on west side of exterior of garage is pulled off house and wire but is exposed. Recommend repair.
Photos

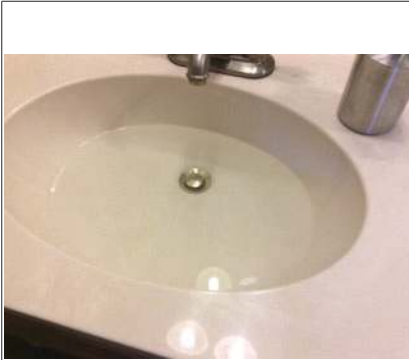
Comments Sinks in master bathroom fill up with water when ran from slow drainage. Recommend consulting plumber for evaluation.
Sheet rock in master bathroom and master closet is wrinkled around edges an area on wall above tub.
Recommend repair.

Sinks in master bathroom fill up with water when ran from slow drainage. Recommend consulting plumber for evaluation.

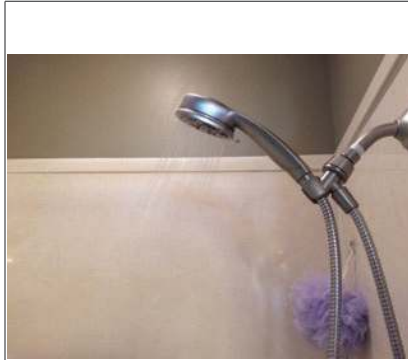
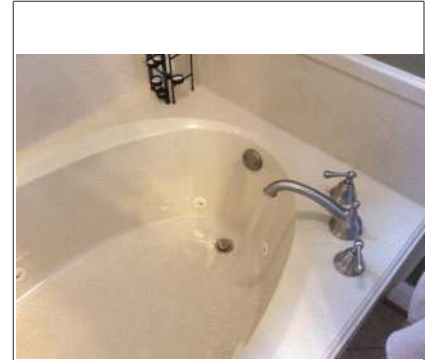
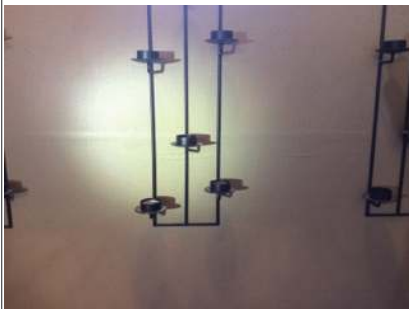
Sheet rock in master bathroom and master closet is wrinkled around edges an area on wall above tub. Recommend repair.

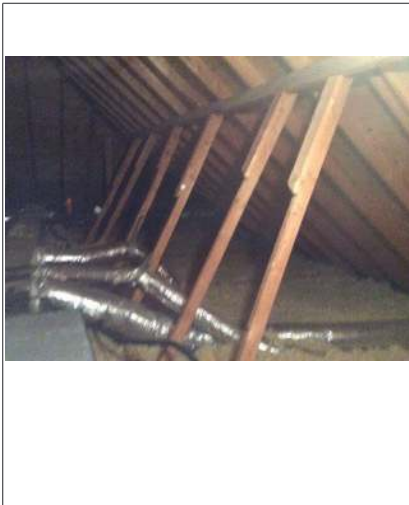
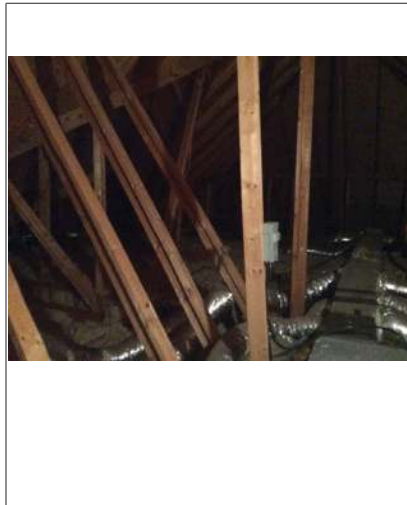
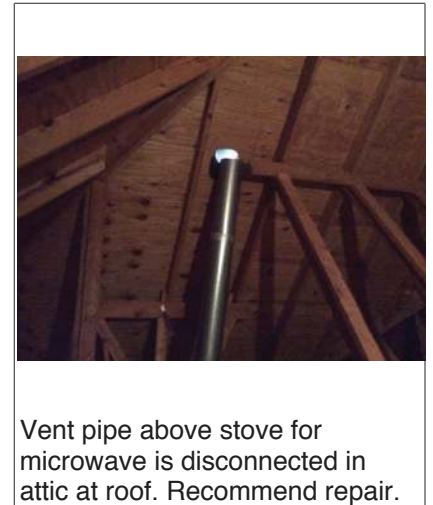
Comments Vent pipe above stove for microwave is disconnected in attic at roof. Recommend repair.

Vent pipe above stove for microwave is disconnected in attic at roof. Recommend repair.

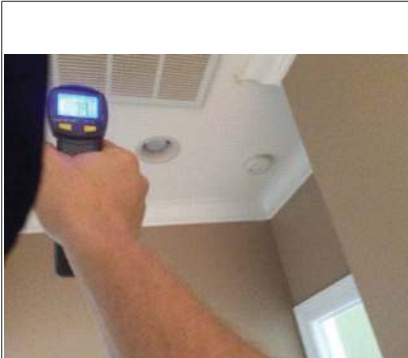
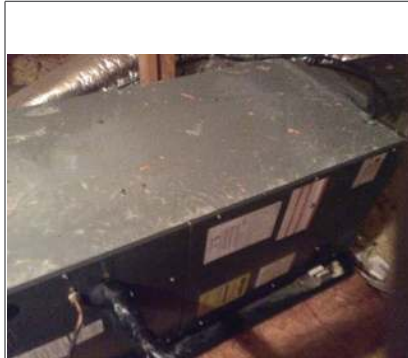
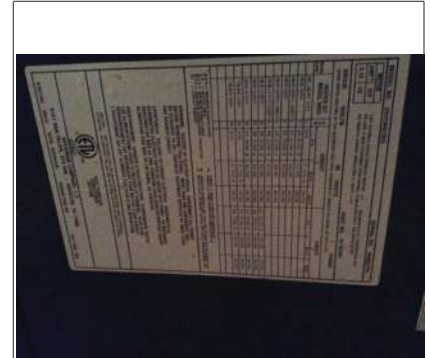
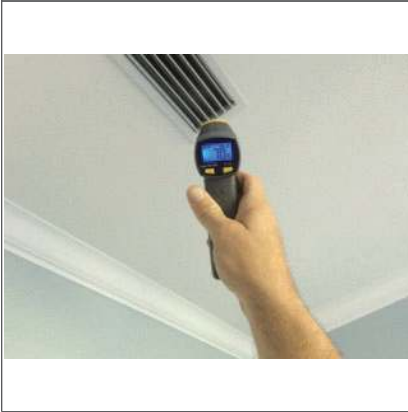
- 1-Some of the water distribution pipe is DuraPex. Recommend consulting plumber for more information on this product.
- 2-Recommend HVAC technician evaluate central system due to age of system and temperature differential.

Comments Recommend HVAC technician evaluate central system due to age of system and temperature differential.
