Home Inspection Report

123 Sample St, Fairhope, AL 36532

Friday, January 4, 2019

1234

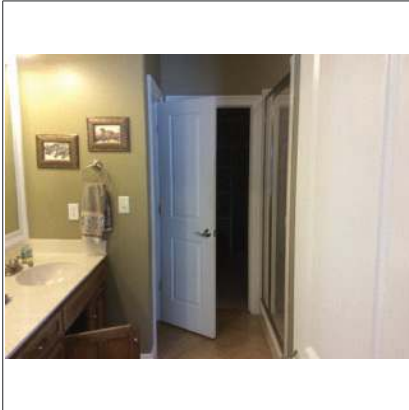
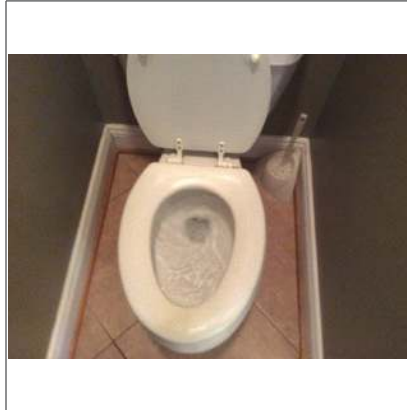
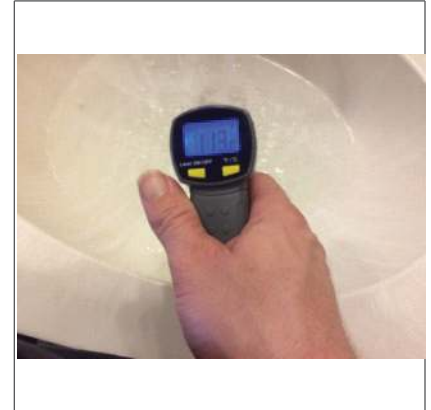
Comments Sinks in master bathroom fill up with water when ran from slow drainage. Recommend consulting plumber for evaluation.
Sheet rock in master bathroom and master closet is wrinkled around edges an area on wall above tub.
Recommend repair.

Sinks in master bathroom fill up with water when ran from slow drainage. Recommend consulting plumber for evaluation.
